**DEPARTMENT OF TRANSPORTATION****DIVISION OF ENGINEERING SERVICES**

Contract #: 04-0120F4Cty: SF/ALA Rte: 80 PM: 13.2/13.9File #: 69.28**WELDING INSPECTION REPORT****Resident Engineer:** Pursell, Gary**Address:** 333 Burma Road**City:** Oakland, CA 94607**Report No:** WIR-015528**Date Inspected:** 05-Jul-2010**Project Name:** SAS Superstructure**OSM Arrival Time:** 700**Prime Contractor:** American Bridge/Fluor Enterprises, a JV**OSM Departure Time:** 1900**Contractor:** Zhenhua Port Machinery Company, Ltd (ZPMC), Changxing Island **Location:** Shanghai, China**CWI Name:** ZPMC and ABF**CWI Present:** Yes No**Inspected CWI report:** Yes No N/A**Rod Oven in Use:** Yes No N/A**Electrode to specification:** Yes No N/A**Weld Procedures Followed:** Yes No N/A**Qualified Welders:** Yes No N/A**Verified Joint Fit-up:** Yes No N/A**Approved Drawings:** Yes No N/A**Approved WPS:** Yes No N/A**Delayed / Cancelled:** Yes No N/A**Bridge No:** 34-0006**Component:** OBG 13 section**Summary of Items Observed:**

## WELDING INSPECTION REPORT

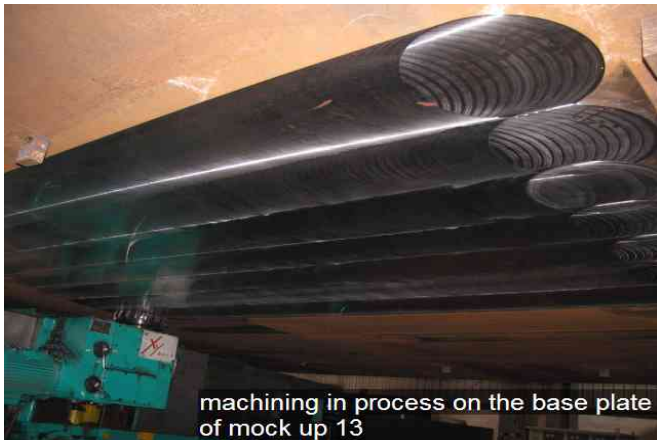
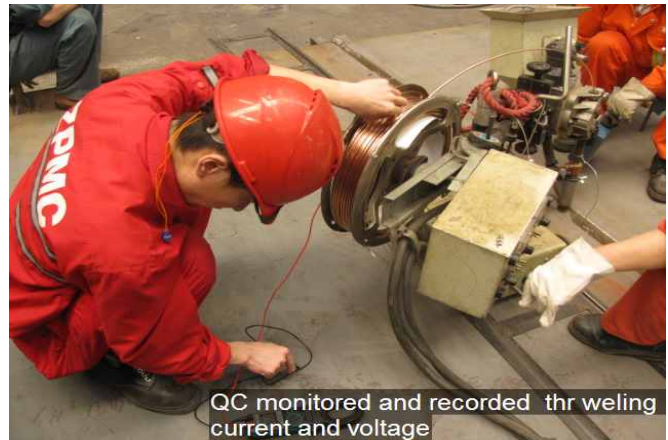
Caltrans QA Inspector observed a welding operator in process of semi-automatic SAW on CJP butt joint weld. The CJP weld is attached to 60mm wall thick base plate of 13AW section of west line. This section is a SPM member. The weld number and plate number are BP3073-001-002/PL3364B and PL3365B (side B). The minimum preheat for SPM member CJP weld is 160C degree. The semi-automatic SAW process was monitored and recorded by ZPMC and ABF QC inspector. Based on Caltrans QAI observations, no discrepancies were noted.
